**DEPARTMENT OF TRANSPORTATION****DIVISION OF ENGINEERING SERVICES**

Contract #: 04-0120F4Cty: SF Rte: 80 PM: 13.2/13.9File #: 1x.28**WELDING INSPECTION REPORT****Resident Engineer:**Pursell, Gary**Address:** 333 Burma Road**City:** Oakland, CA 94607**Report No:** WIR-001009**Date Inspected:** 14-Dec-2007**Project Name:** SAS Superstructure**OSM Arrival Time:** 600**Prime Contractor:** American Bridge/Fluor Enterprises, a JV**OSM Departure Time:** 1300**Contractor:** American Bridge/Fluor Enterprises, a JV**Location:** Benicia, CA**CWI Name:** William Norris**CWI Present:** Yes No**Inspected CWI report:** Yes No N/A**Rod Oven in Use:** Yes No N/A**Electrode to specification:** Yes No N/A**Weld Procedures Followed:** Yes No N/A**Qualified Welders:** Yes No N/A**Verified Joint Fit-up:** Yes No N/A**Approved Drawings:** Yes No N/A**Approved WPS:** Yes No N/A**Delayed / Cancelled:** Yes No N/A**Bridge No:** 34-0006**Component:** Procedure Qualification Record (PQR) test**Summary of Items Observed:**

ABF-PQR-028-1.

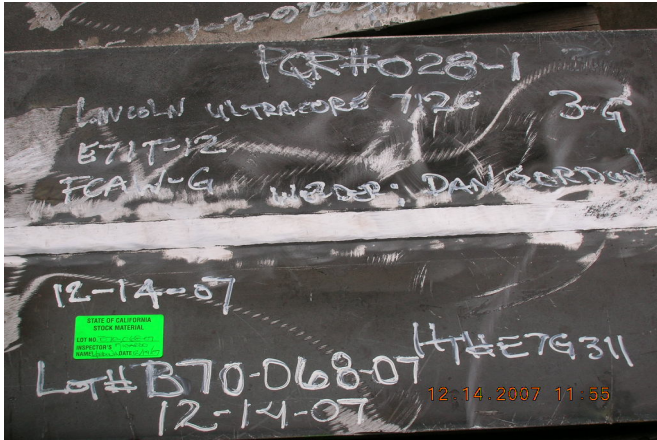
b) After cutting and grinding were completed the PQR test plate was visually inspected by QC Inspector William Norris. William Norris notified the QA Inspector the test plate was visually acceptable in accordance with AWS D1.5-2002. The QA Inspector performed visual verification and observed test plate appeared to be in general compliance with the project plans and specifications.

c) QA Inspector assigned a Caltrans Index Lot Number to test plate for tracking purposes and a Welding Witness Report (TL-6032) was generated on this date. Please see digital images below.
